## III.A.3 Materials Solutions for Hydrogen Delivery in Pipelines

Contract Number: DE-FG36-05-GO 15036

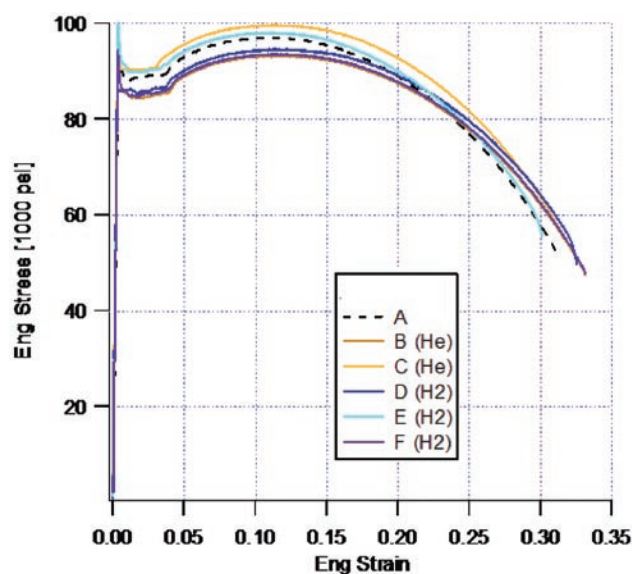
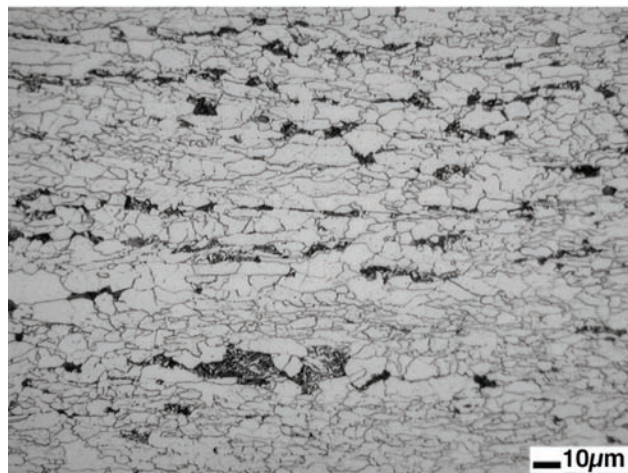
**FIGURE 1.** Stress-Strain Curves and Microstructure from Specimens of Steel A after *Ex-Situ* Hydrogen Charging under High Pressures

**Microstructure: Ferrite + Pearlite**  
**Yield Stress: Intermediate**  
**Note stress- strain curves variability**

Figures 1-3 show the results of tensile tests from Steels A, B, and C along with their microstructures. Table 4 shows a summary of the test results. Results show that there is very little effect of hydrogen charging in Steel B but a tendency to reduce the failure strains in Steels A and C. These results are preliminary and need to be studied in greater detail. This is the beginning of numerous high pressure hydrogen testing that needs to be completed to understand the effect of high pressure hydrogen gas on the embrittlement of various pipeline steel alloy/microstructure designs.

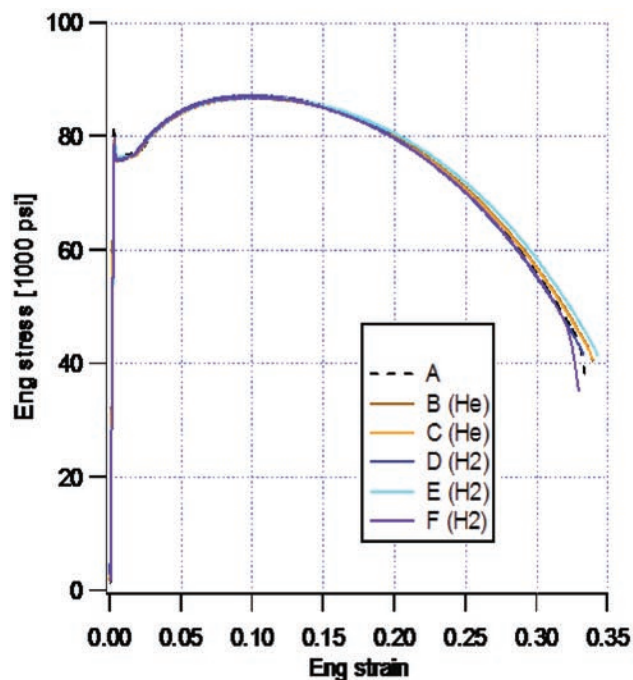
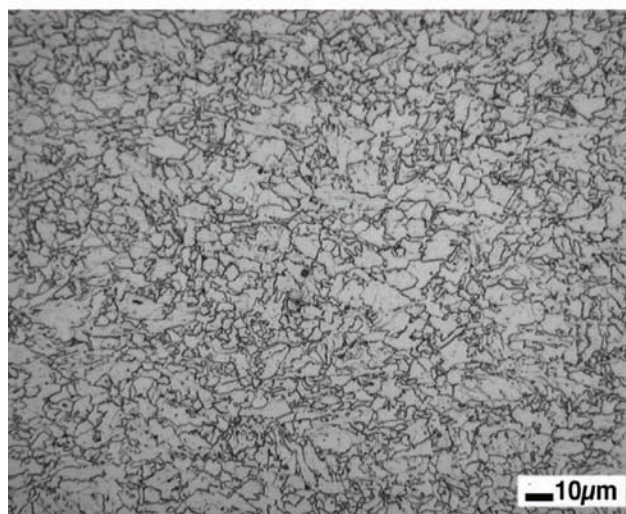
**FIGURE 2.** Stress-Strain Curves and Microstructure from Specimens of Steel B after *Ex-Situ* Hydrogen Charging under High Pressures

**Microstructure: Ferrite + Acicular Ferrite**  
**Yield Stress: Low**  
**Note consistent stress-strain curves**

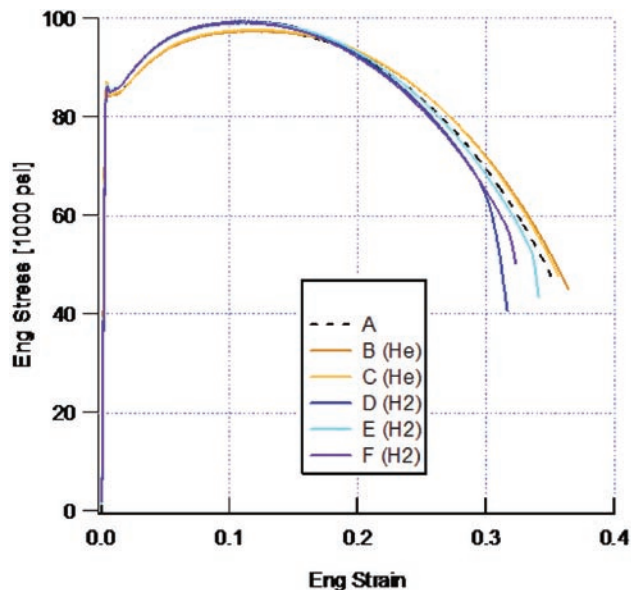
**FIGURE 3.** Stress-Strain Curves and Microstructure from Specimens of Steel C after *Ex-Situ* Hydrogen Charging under High Pressures

**Microstructure:** Ferrite/acicular ferrite + small quantity pearlite  
**Yield Stress:** High  
**Note stress-strain curve with slight variability**

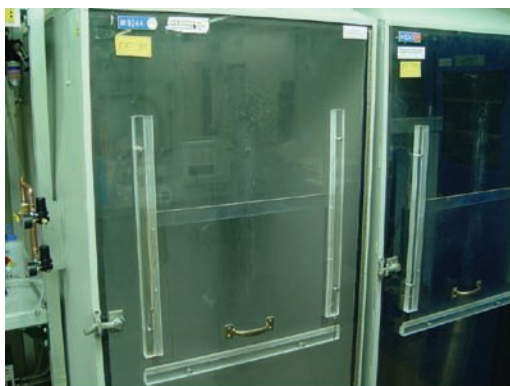
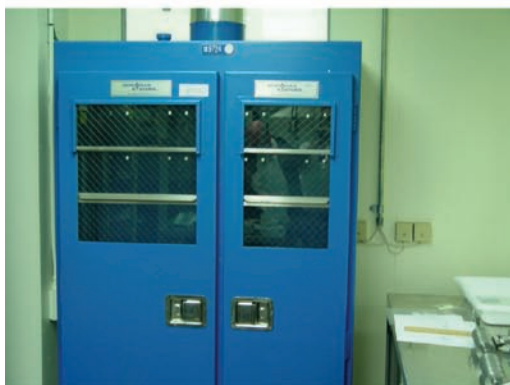
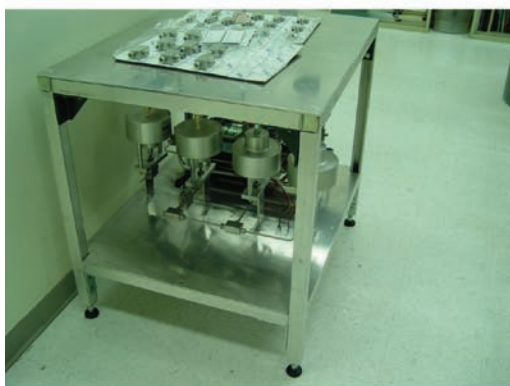
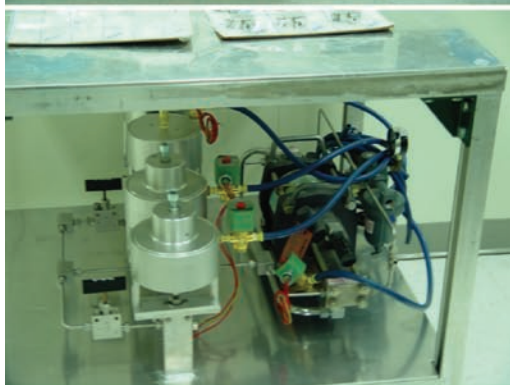
**FIGURE 4.** Various Critical Components and Partially Assembled Systems that will be utilized for Delivery of High-Pressure Hydrogen to the Mechanical Testing System at ORNL

**Cubicle for Tests**

**Gas Storage**

**Booster Pump and Actuators**

Significant progress has also been achieved in the assembly of equipment for mechanical testing *in-situ* in a hydrogen atmosphere at high pressures at both ORNL and ATC. An internal safety review has been performed and approval for proceeding with assembly of the facility has been granted. A detailed safety plan was completed and provided to DOE. Figures 4 and 5 show the various assembled pieces of equipment for mechanical testing of steels in high pressure hydrogen atmospheres at both ORNL and ATC.
